**St. Marys River Area of Concern:  
Bar River Habitat Project – 2013 Follow-up**

**November 2013**

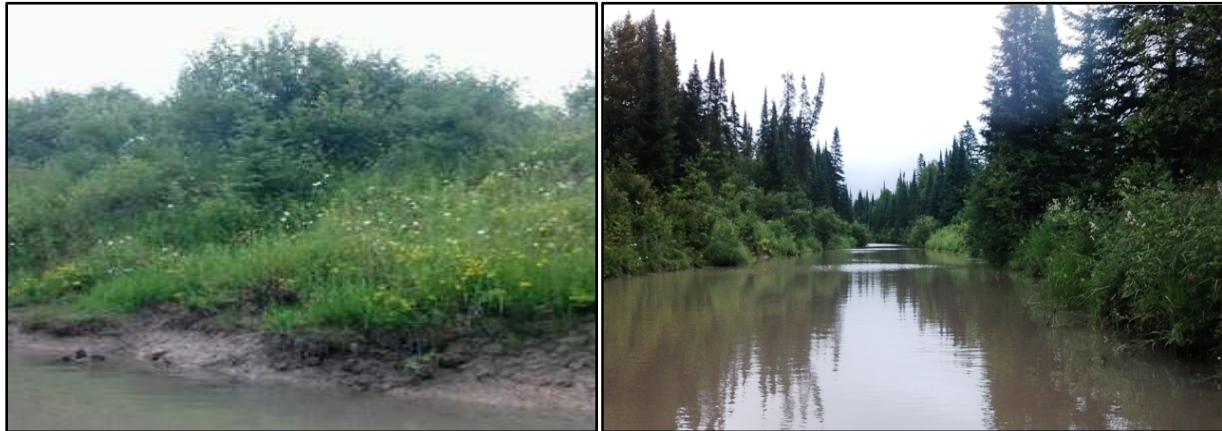
*Phalaris arundinacea* (reed canarygrass), *Typha* sp. (cattail), and *Sparganium fluctuans* (floating burreed). Restoration activities here consisted of bank stabilization by means of riparian plantings. Some banks in this stretch of the river were observed to be exposed and susceptible to erosion (Figure 4, approximate sub-location A), but the overall area of the river surveyed remained well-vegetated (Figure 5).

**Figure 4 (left) demonstrating certain areas prone to erosion. Figure 5 (right) shows the highly vegetated areas of the river overall.**

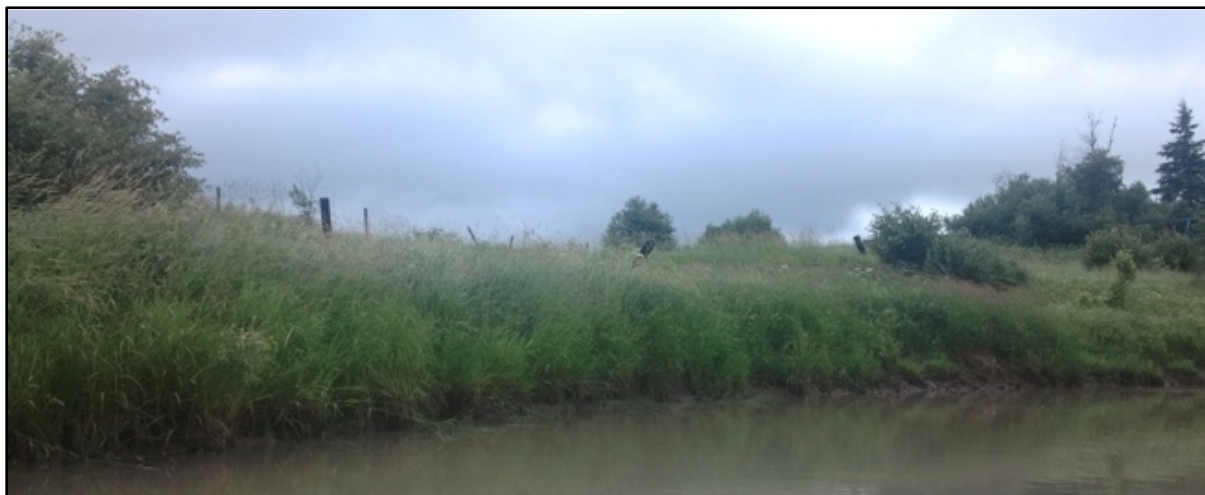
Areas were observed where fencing was installed to restrict livestock from accessing the river (Figure 6, approximate sub-location B). However, it is not known if this fencing was part of the Bar River Habitat Project or independently installed by the landowners.

**Figure 6: Livestock restriction fencing along riverbank.**

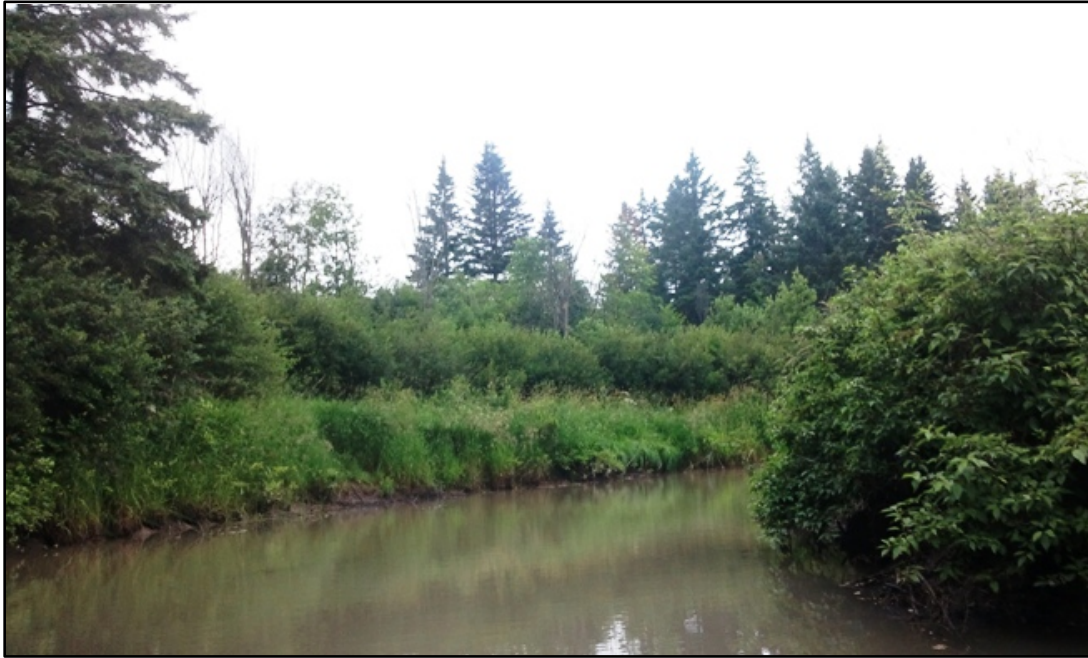
Past riparian plantings were observed at the riverbank near sub-location C. The bank appeared to be well-vegetated with high plant survival rates. Plantings appeared to be in layers to accommodate the

Figure 7: Layered riparian planting at riverbank with tree planting observed farther upland.

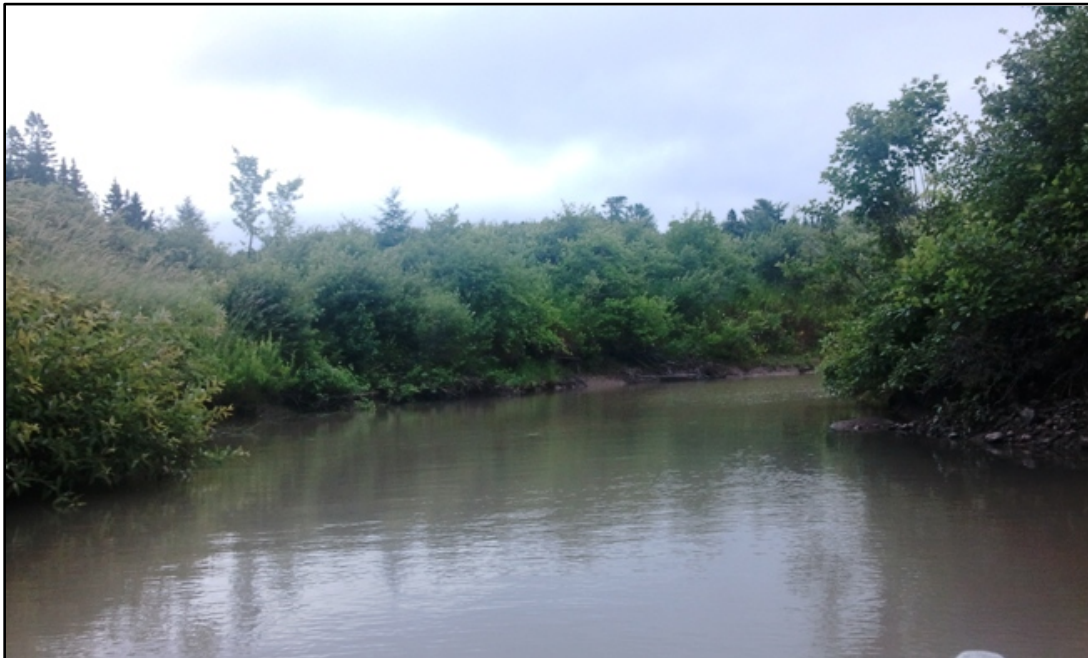
Figure 8: Layered riparian planting observed at riverbank.

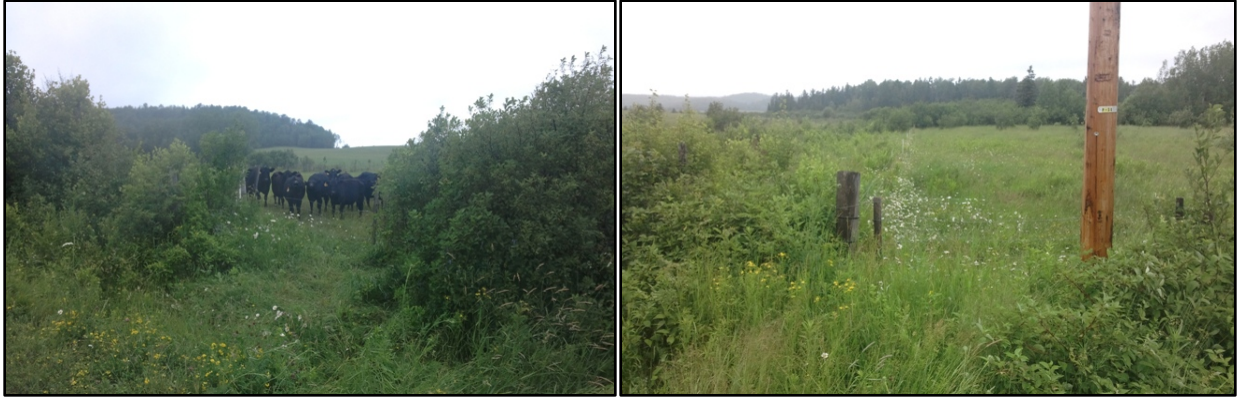
The Watson Road site plantings started from the road crossing and continued to approximately 150 m upstream of the road crossing on the Bar River (Neave; Figure 9). The site assessment was conducted on foot. A herd of cattle was observed to the west of the Bar River at the Watson Road location (sub-location D, Figure 10). Fencing was observed on both sides of the river (sub-locations D and E; Figure 11).

**Figure 10 (left): cattle herd observed at sub-location D. Figure 11 (right): livestock fencing observed on both sides of the river.**

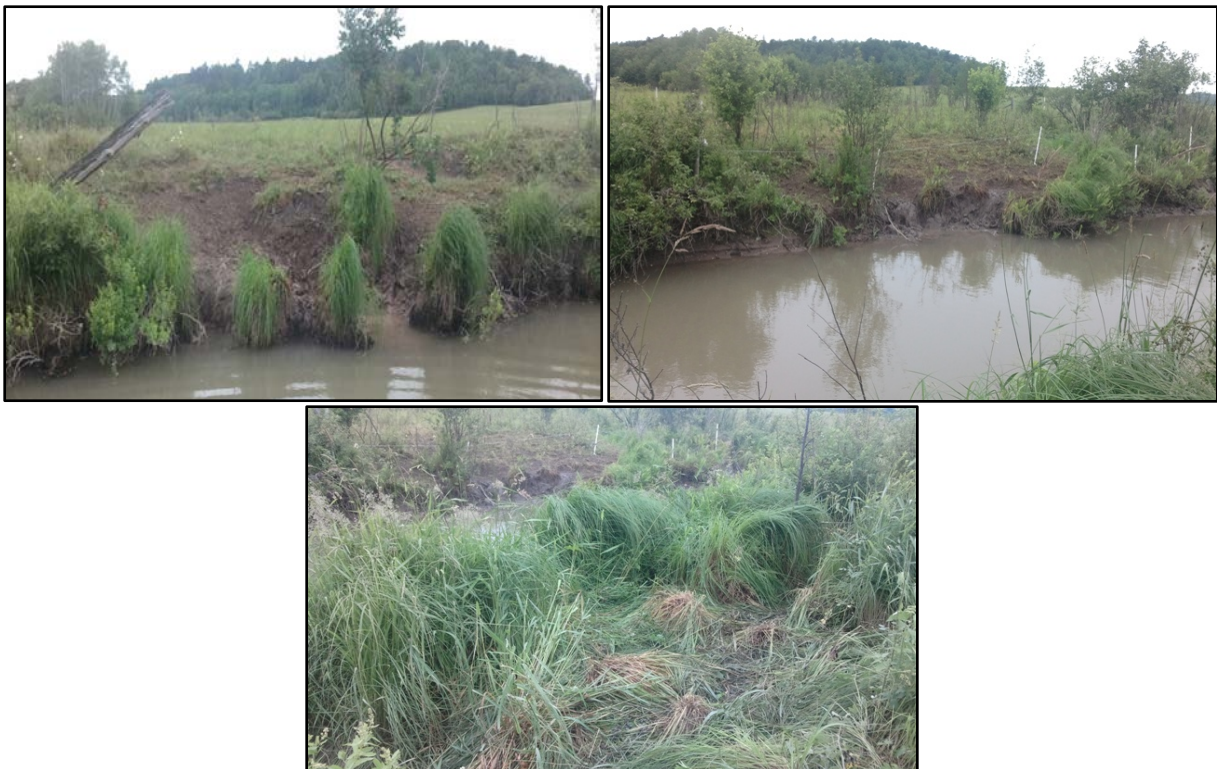
At sub-location F, the livestock restriction fencing failed in certain areas. Evidence of cattle disturbance along the riverbank and subsequent access to the watercourse were observed on both sides of the river (Figures 12, 13, and 14).

**Figure 12 (upper left) and Figure 13 (upper right): Cattle disturbance of the bank on the west side of the Watson Road location. Figure 14 (bottom): Cattle disturbance of the bank on the east side.**

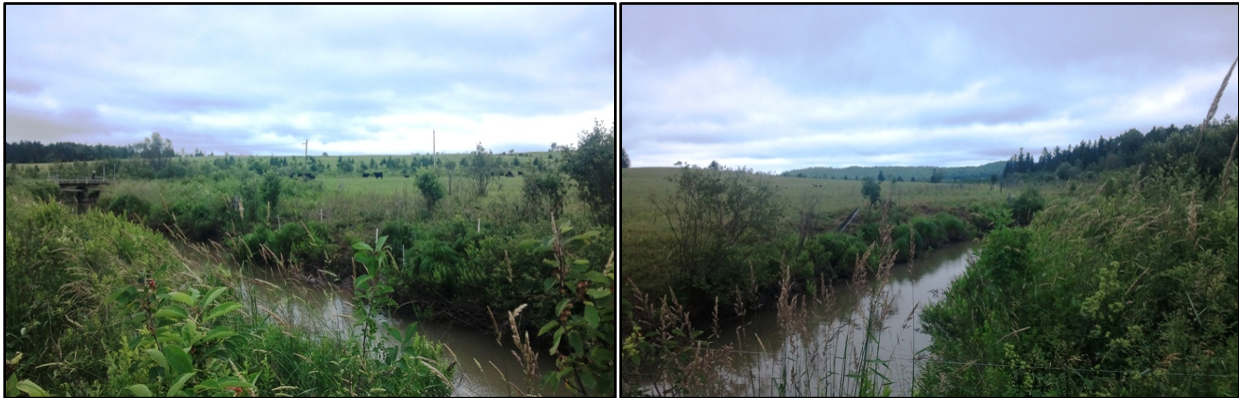
Riparian plantings observed above the riverbank appeared to be in good condition (Figures 15, 16).

Figure 15 (left): Riparian plantings facing south of the Watson Road restoration site. Figure 16 (right): Riparian plantings facing north.

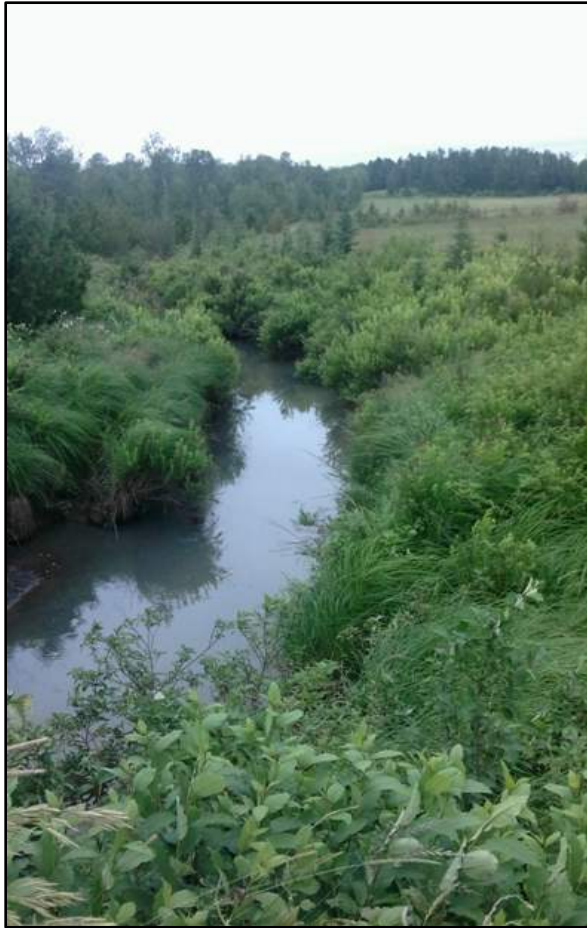
Riparian planting on both sides of the creek was evident along the creek and appeared to be in good condition (Figure 18, sub-location G).

**Figure 18: Well-vegetated riparian zone facing north at Mill Creek.**

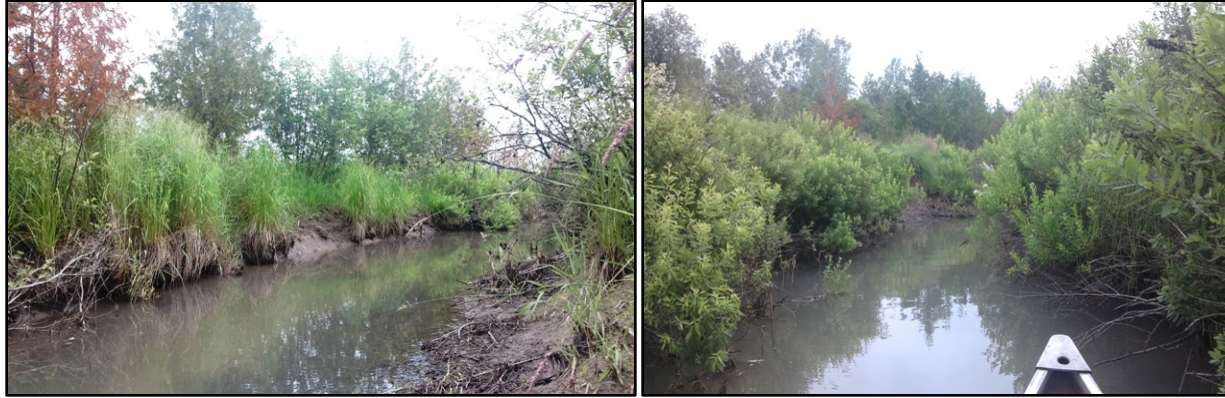
Farther upstream (sub-location H), there were some areas of minor erosion noted (Figure 19), but the creek remained well-vegetated throughout (Figure 20).

**Figure 19 (left): Areas of minor erosion at sub-location H. Figure 20 (right): Overall riverbank remains well-vegetated at sub-location H.**

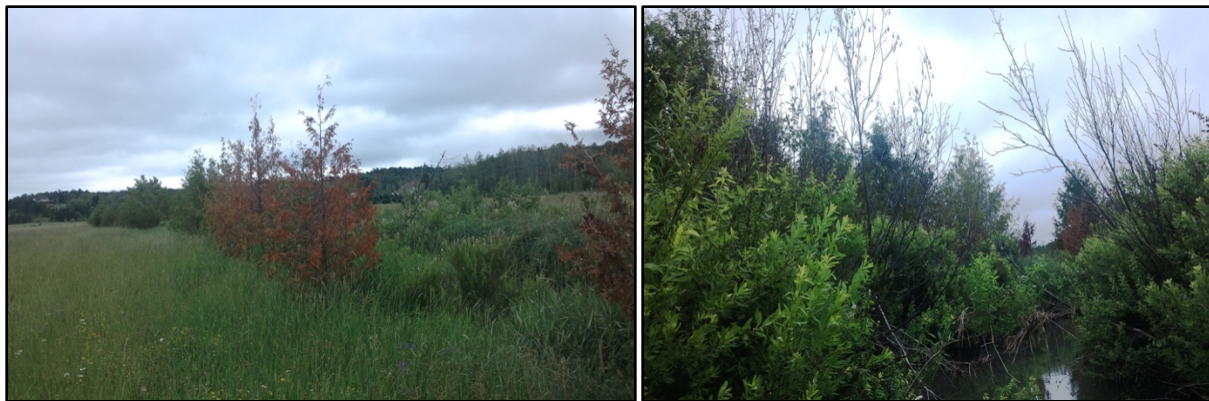
At sub-location I, various tree plantings were observed higher on the bank. Some of these upland trees appeared dead or in poor condition at the time of the site visit (Figure 21); nonetheless, the vegetation at the water's edge remained in good condition (Figure 22).

**Figure 21 (left): Upland trees at sub-location I; some trees appeared brown during mid-summer. Figure 22 (right): Riparian vegetation at riverbank sub-location I remained in good condition.**
