**St. Marys River Area of Concern:  
Bar River Habitat Project – 2013 Follow-up**

**November 2013**

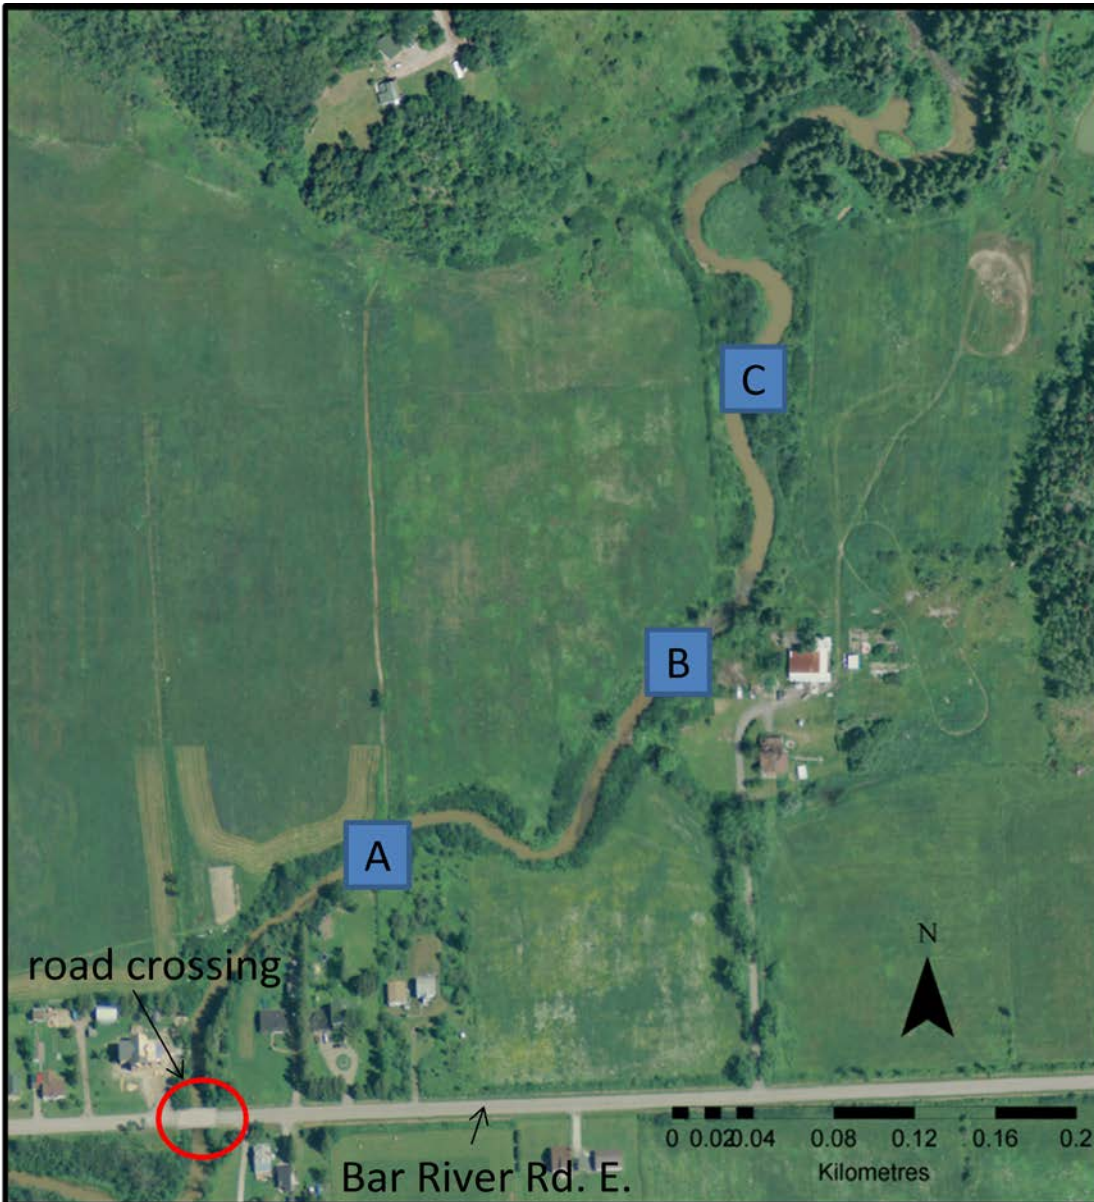
**Figure 3: Bar River Road site. Sub-locations along the Bar River located at A, B, and C.**

The Bar River Road site plantings were 400-600 metres upstream of the road crossing (Neave; Figure 3). During the site visit on July 10<sup>th</sup>, 2013, the water at the Bar River Road site was assessed visually; turbidity was significantly high at sub-location A, but was clearer at sub-locations B and C. Emergent and submerged plant species included *Equisetum fluviatile* (water horsetail), *Potamogeton gramineus* (variableleaf pondweed), *Sagittaria latifolia* (broadleaf arrowhead), *Iris versicolor* (harlequin blueflag),

*Phalaris arundinacea* (reed canarygrass), *Typha* sp. (cattail), and *Sparganium fluctuans* (floating burreed). Restoration activities here consisted of bank stabilization by means of riparian plantings. Some banks in this stretch of the river were observed to be exposed and susceptible to erosion (Figure 4, approximate sub-location A), but the overall area of the river surveyed remained well-vegetated (Figure 5).

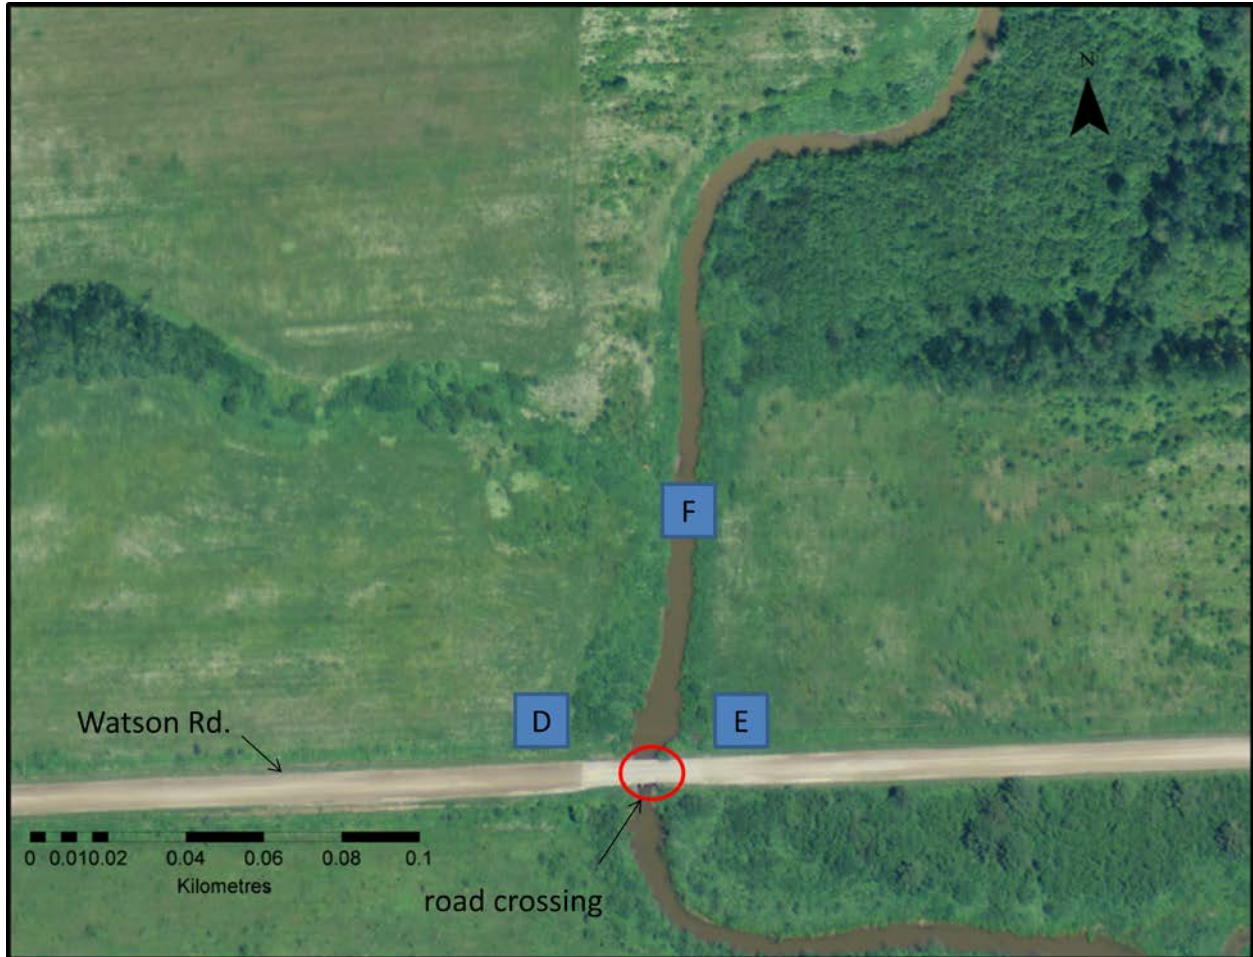
**Figure 9: Sub-locations D, E, F at the Watson Road restoration site**

The Watson Road site plantings started from the road crossing and continued to approximately 150 m upstream of the road crossing on the Bar River (Neave; Figure 9). The site assessment was conducted on foot. A herd of cattle was observed to the west of the Bar River at the Watson Road location (sub-location D, Figure 10). Fencing was observed on both sides of the river (sub-locations D and E; Figure 11).

At sub-location F, the livestock restriction fencing failed in certain areas. Evidence of cattle disturbance along the riverbank and subsequent access to the watercourse were observed on both sides of the river (Figures 12, 13, and 14).

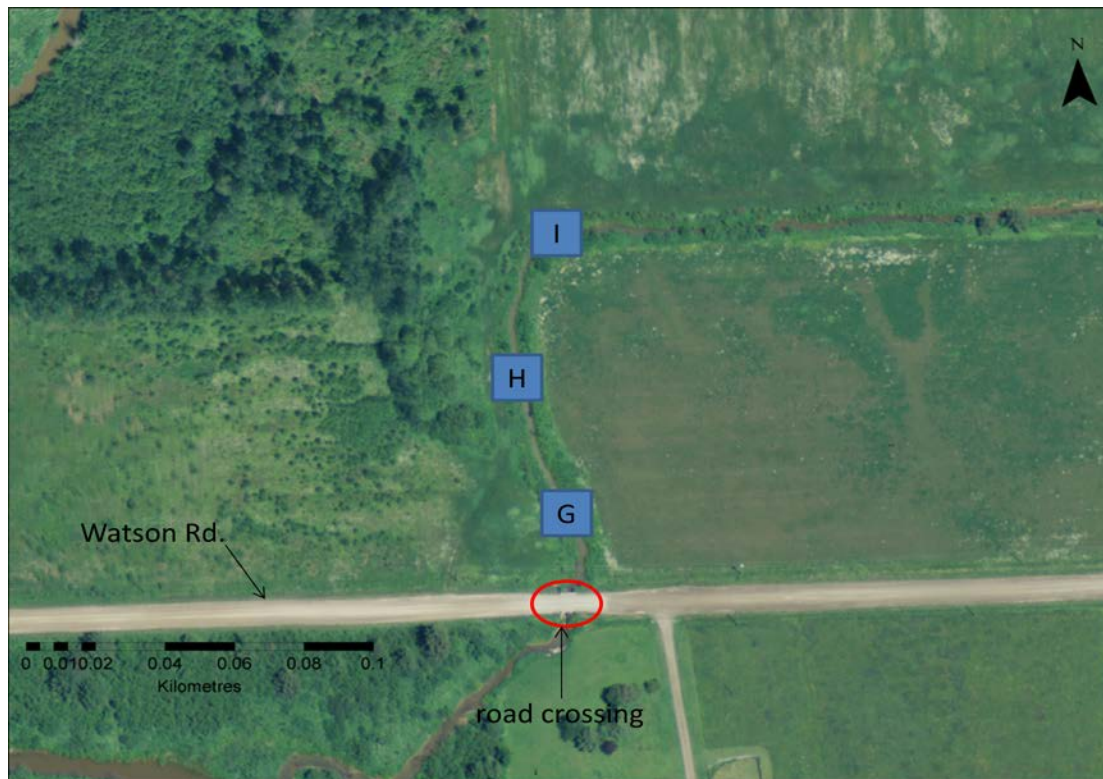
Figure 17: Mill Creek restoration site with sub-locations G, H, and I.

The Mill Creek site was explored via canoe and on foot. Riparian planting was conducted approximately 300 meters upstream of the road crossing at Watson Road (Neave; Figure 17).

Riparian planting on both sides of the creek was evident along the creek and appeared to be in good condition (Figure 18, sub-location G).

Farther upstream (sub-location H), there were some areas of minor erosion noted (Figure 19), but the creek remained well-vegetated throughout (Figure 20).

At sub-location I, various tree plantings were observed higher on the bank. Some of these upland trees appeared dead or in poor condition at the time of the site visit (Figure 21); nonetheless, the vegetation at the water's edge remained in good condition (Figure 22).
