Geophysical Survey of the St. Marys River at Sault Ste. Marie, Ontario

Prepared by: D. L. Keyes McQuest Marine Sciences Limited 489 Enfield Road Burlington, Ontario L7T 2X5

Prepared for: Ontario Ministry of the Environment Environmental Monitoring & Reporting Branch Water Monitoring Section Etobicoke, Ontario M9P 3V6

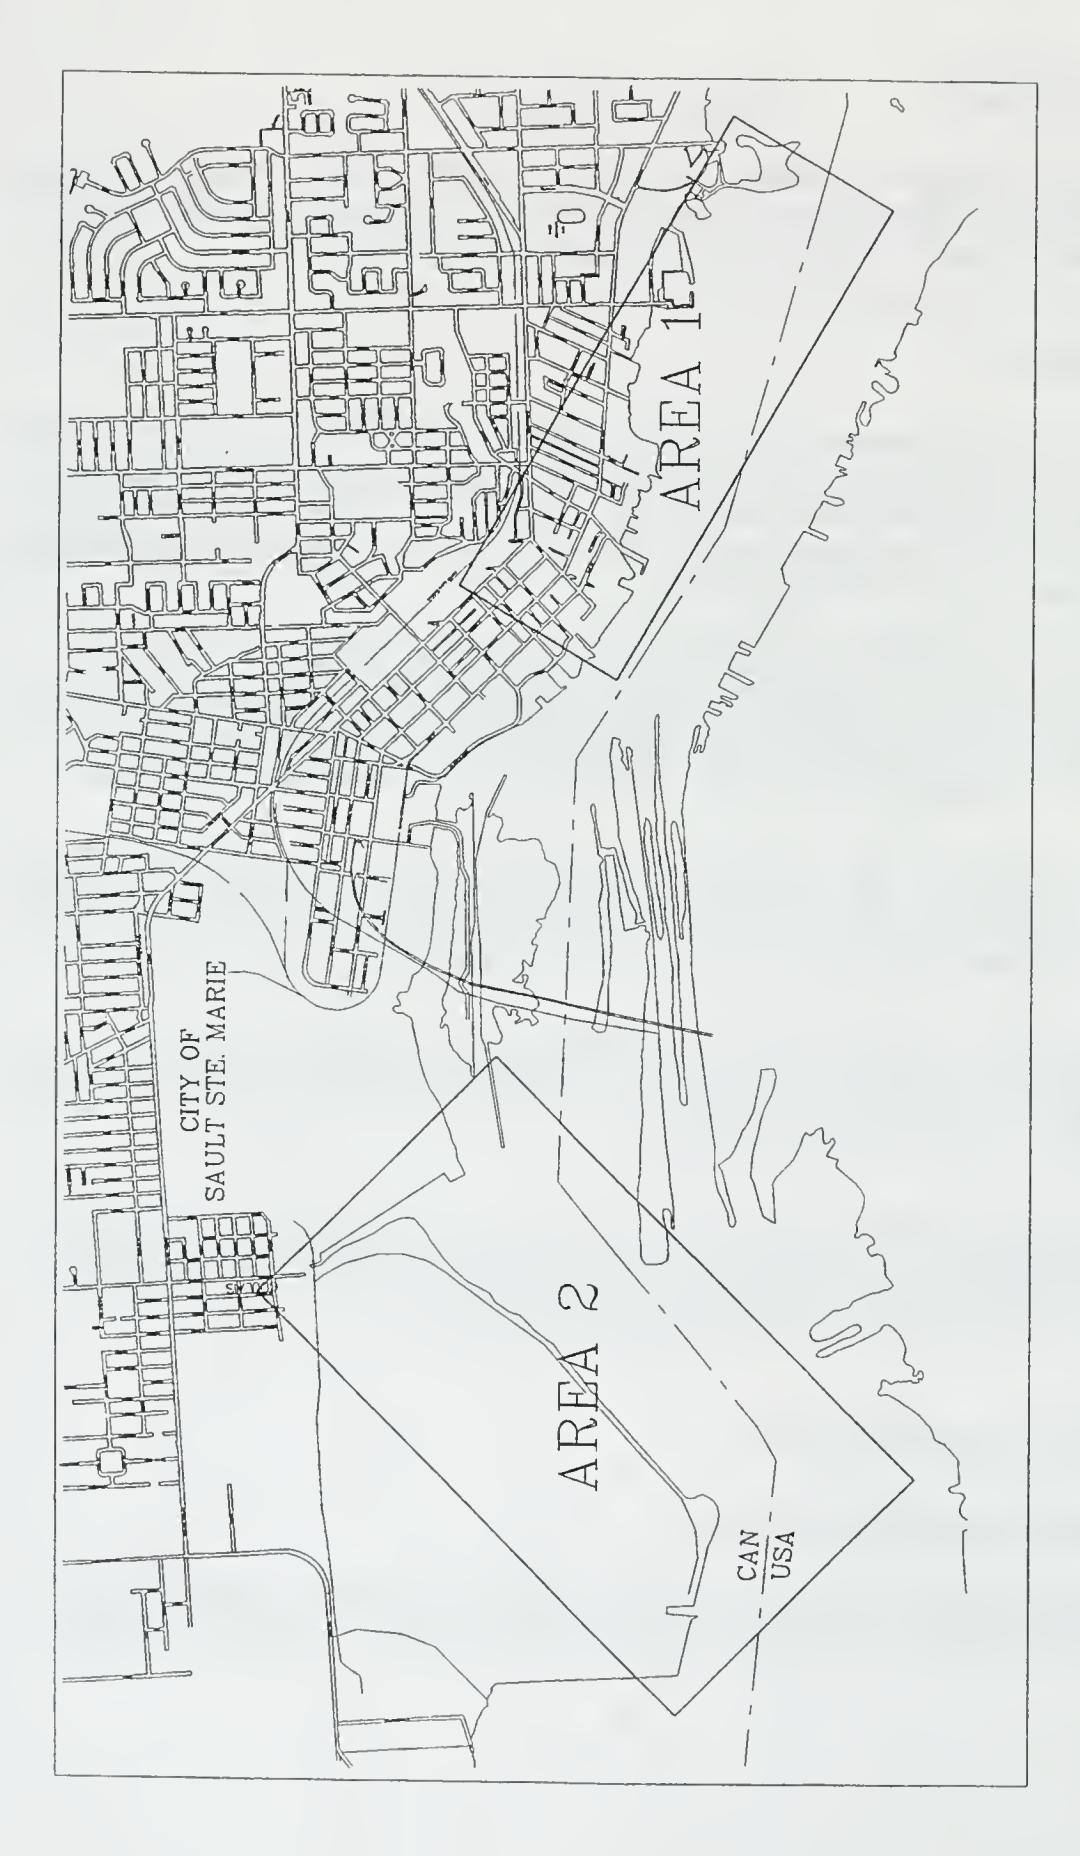
| Numbe | r <u>Title</u> <u>Page</u> | <u>e</u> |
|---|--|---|
| 1 | Survey Areas: Area 1 (Bellevue Marine Park); and Area 2 (Algoma Slag Dump - Algoma Slip). | . 2 |

Two areas were surveyed. One of these (approximately 2.2 km by 1.4 km) is located in Bellevue Marine Park (see Fig. 1, Area 1). The other area (approximately 2.8 km by 0.4 km) was located offshore of the Algoma Slag Dump and extended into the Algoma Slip (see Fig. 1, Area 2).

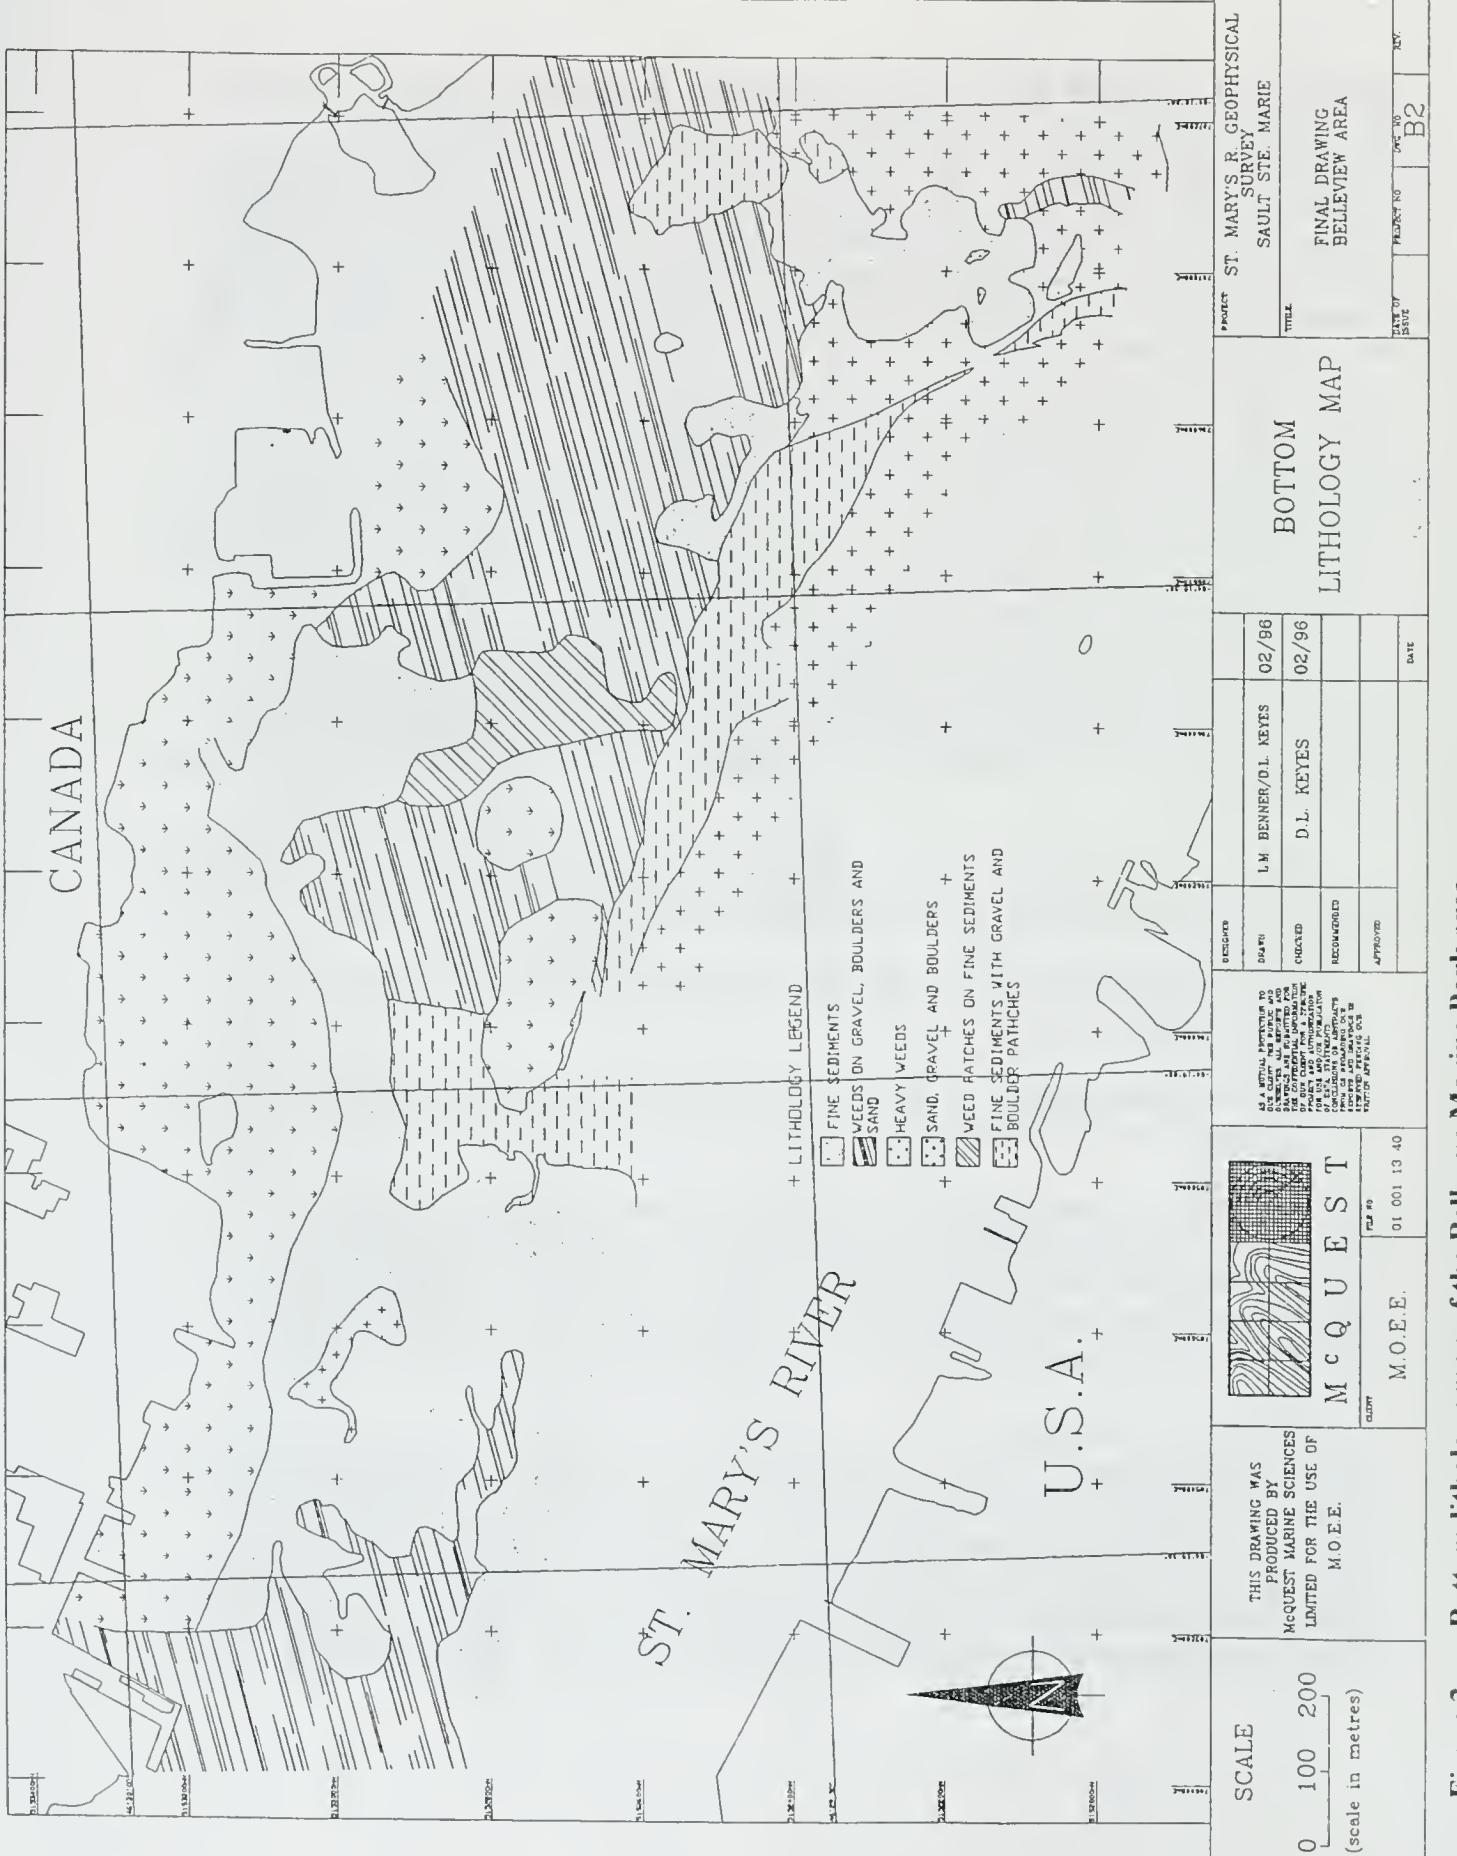
Figure 2.

2. Bottom lithology map of the Bellevue Marine Park area.

A, Drawing A1; Appendix B, Drawing B1). A lithological interpretation was performed for each area using these track plots and the respective side scan sonar records. The results are presented in Figures 2 and 3. The purpose of these lithological interpretations was to map the distribution and types of surface sediments in each area. Anthropogenic targets (e.g., anchor drags, tires, debris, etc.) were also revealed by the side scan records and are presented in Figures 4 and 5. Initially, the various sediment types encountered were classified based on the interpreter's prior experience from side scan data and 'ground truthing' results collected in other areas. Initial results were shown to the client, P. Kauss of the OMOEE. It was jointly decided at this time to compare the side scan sonar lithological interpretation to the 'ground truthing' results of the Bellevue and Algoma areas collected earlier in September by OMOEE. It was also decided to compare the lithological interpretation to the preliminary Roxanne® (an acoustic bottom discrimination system; see for e.g., Rukavina, 1996) data of the same areas collected two weeks earlier by the National Water Research Institute (NWRI), Canada Centre for Inland Waters (N. Rukavina, pers. comm., Sept. 1995). The "ground truthing" results consisted of several sample site locations (see Appendix A, Drawing A2; and Appendix B, Drawing B2), with accompanying sample descriptions, photographs of cores and grab samples, as well as underwater video observations obtained by diver or Mini Rover® submersible. The ground truthing results are tabulated in Appendix C. Photographs and videos are on file at the Environmental Monitoring and Reporting Branch, Water Monitoring Section office in Etobicoke (contact P. Kauss).

For the Bellevue and the Algoma Areas, the lithological interpretations agreed very well with the ground truthing results. Some minor discrepancies were likely due to the following:

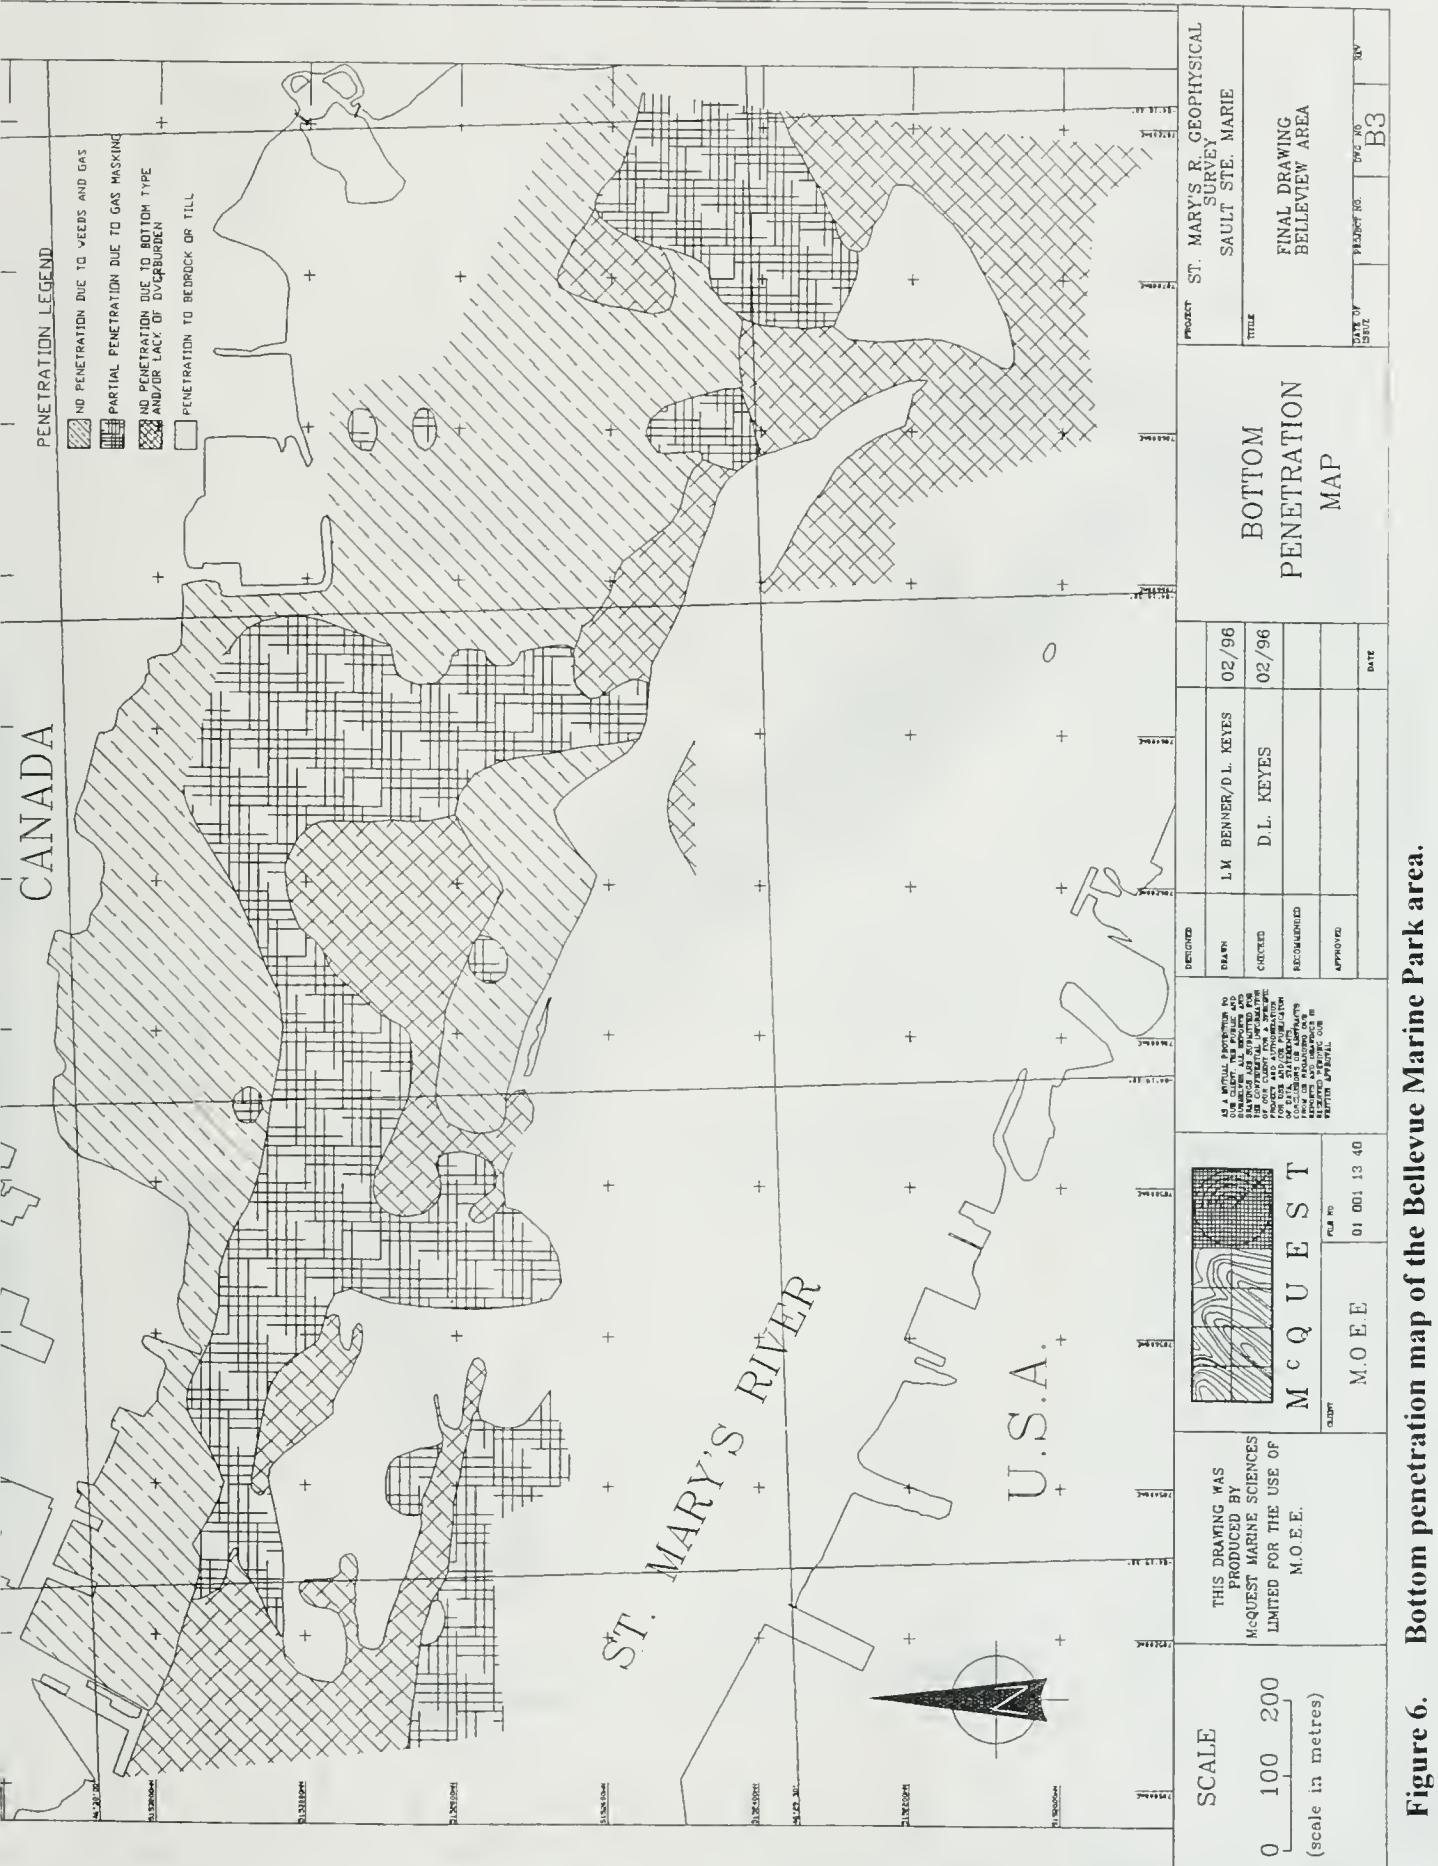
| Numbe | r <u>Title</u> <u>Page</u> | <u>e</u> |
|---|--|---|
| 6 | Bottom penetration map of the Bellevue Marine Park area | . 9 |

Sub-bottom profile data in the Bellevue area was generally poor with little or no bottom penetration due to gaseous sediments, shallow water, and extensive weed coverage. The *Klein* system provided better results than the *DataSonics* system in this area. A bottom penetration map was prepared (see Fig. 6). This bottom penetration map shows the following zone types:

- a) no penetration due to weeds and gas.
- b) partial penetration due to gas masking.
- c) no penetration due to bottom type and/or lack of overburden.
- d) penetration to bedrock or till.

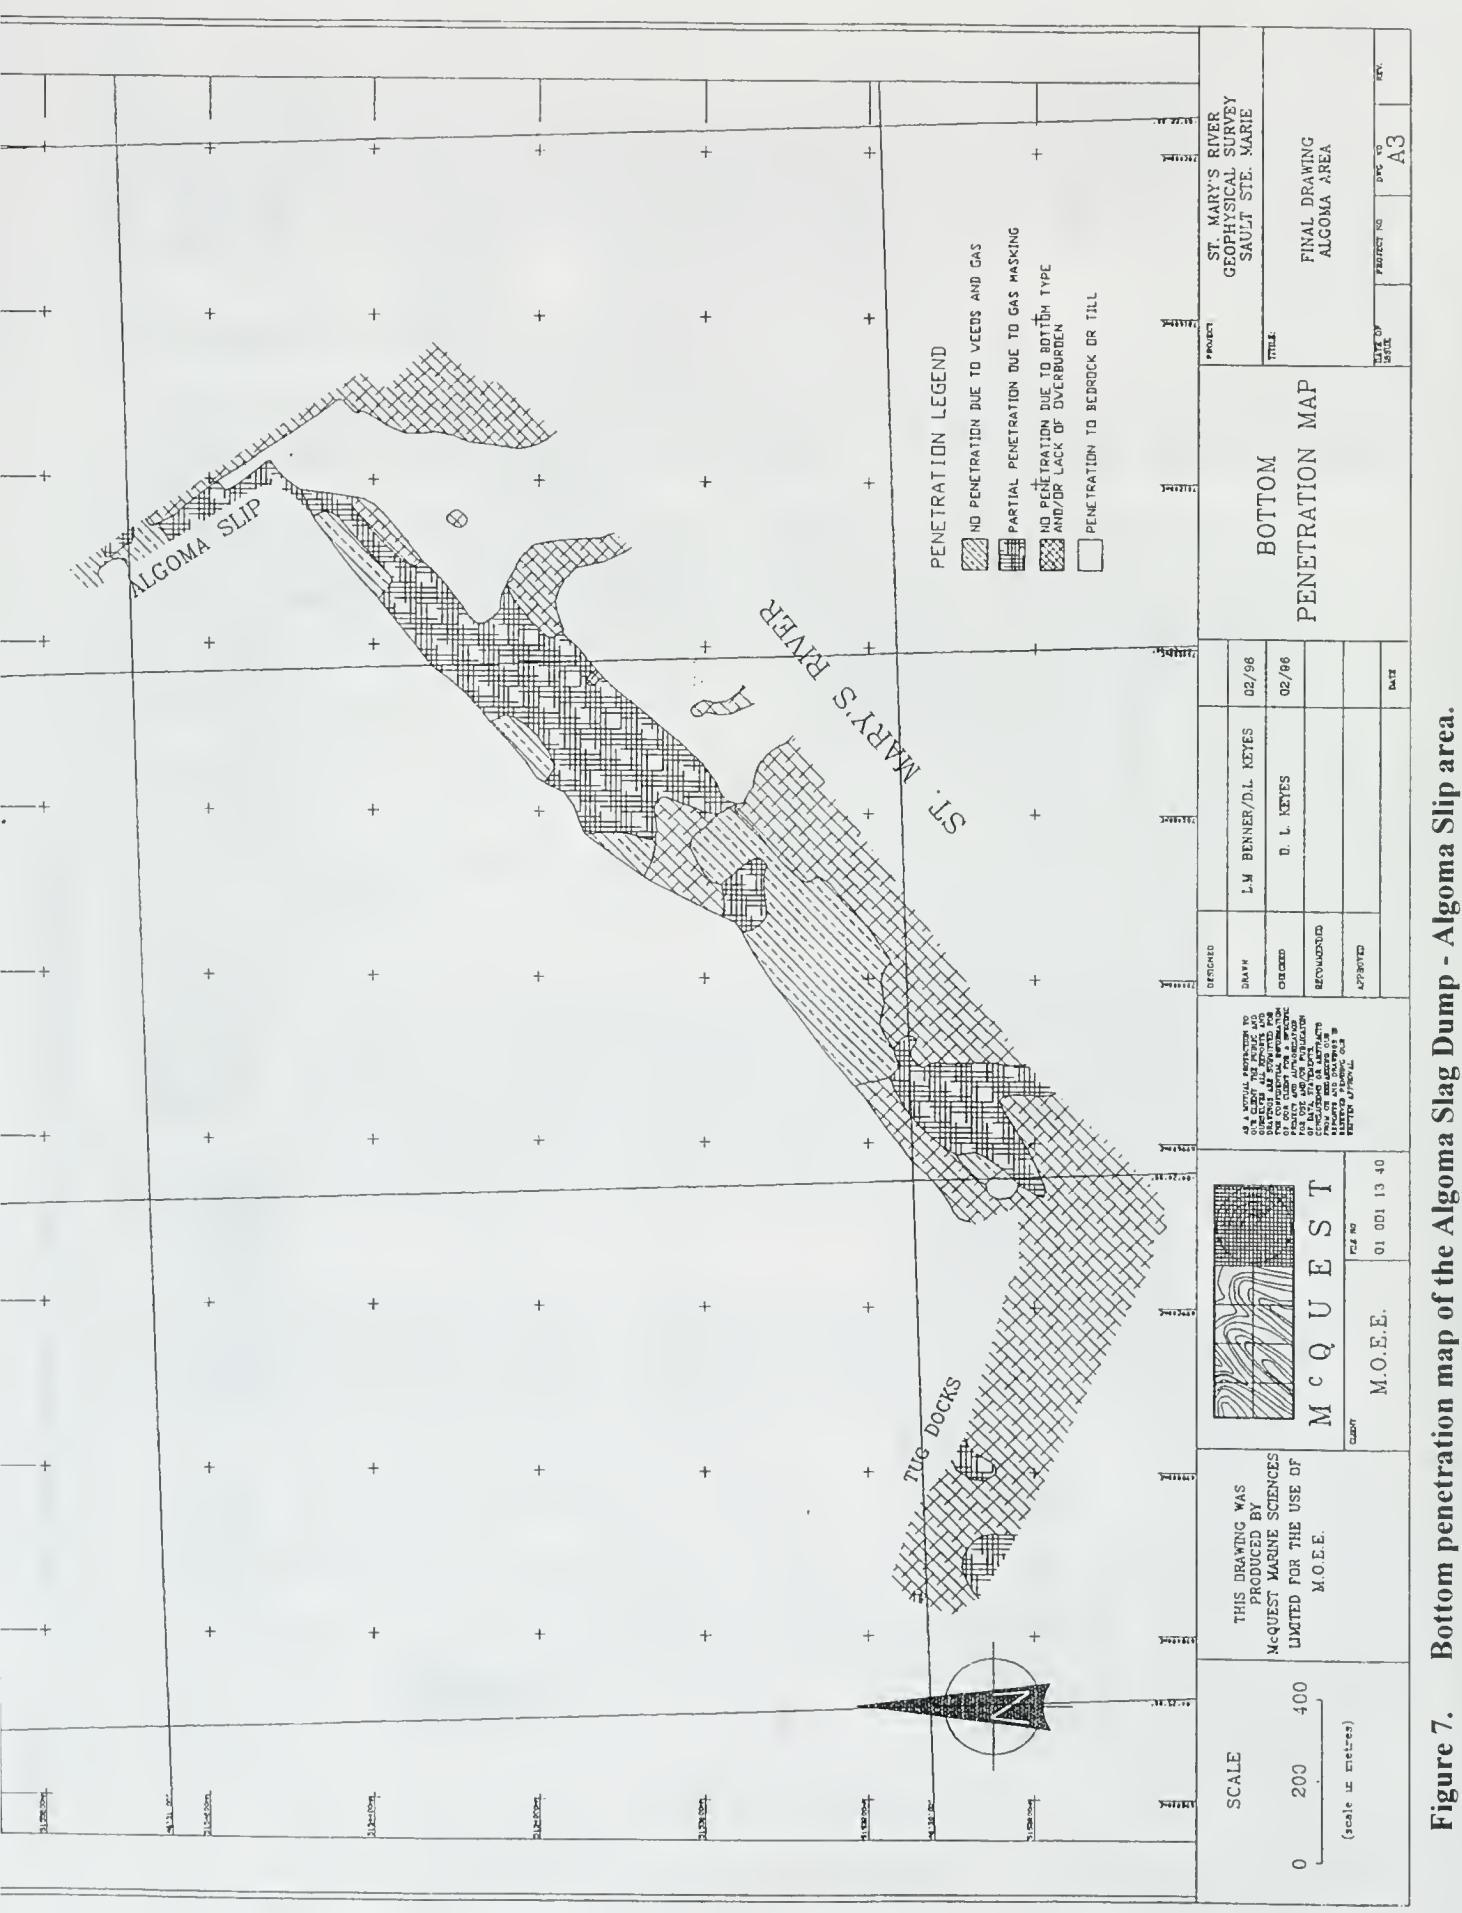
Bottom penetration map of the Algoma Slag Dump - Algoma Slip area.

Sub-bottom profile data in the Algoma area was good in the offshore areas with penetration up to 24 metres in the glaciolacustrine clays. Again the *Klein* system provided better results than the *DataSonics* in this area. A bottom penetration map was prepared (see Fig. 7). This bottom penetration map shows the following zone types:

- a) no penetration due to weeds and gas.
- b) partial penetration due to gas masking.
- c) no penetration due to bottom type and / or lack of overburden.
- d) penetration to bedrock or till.

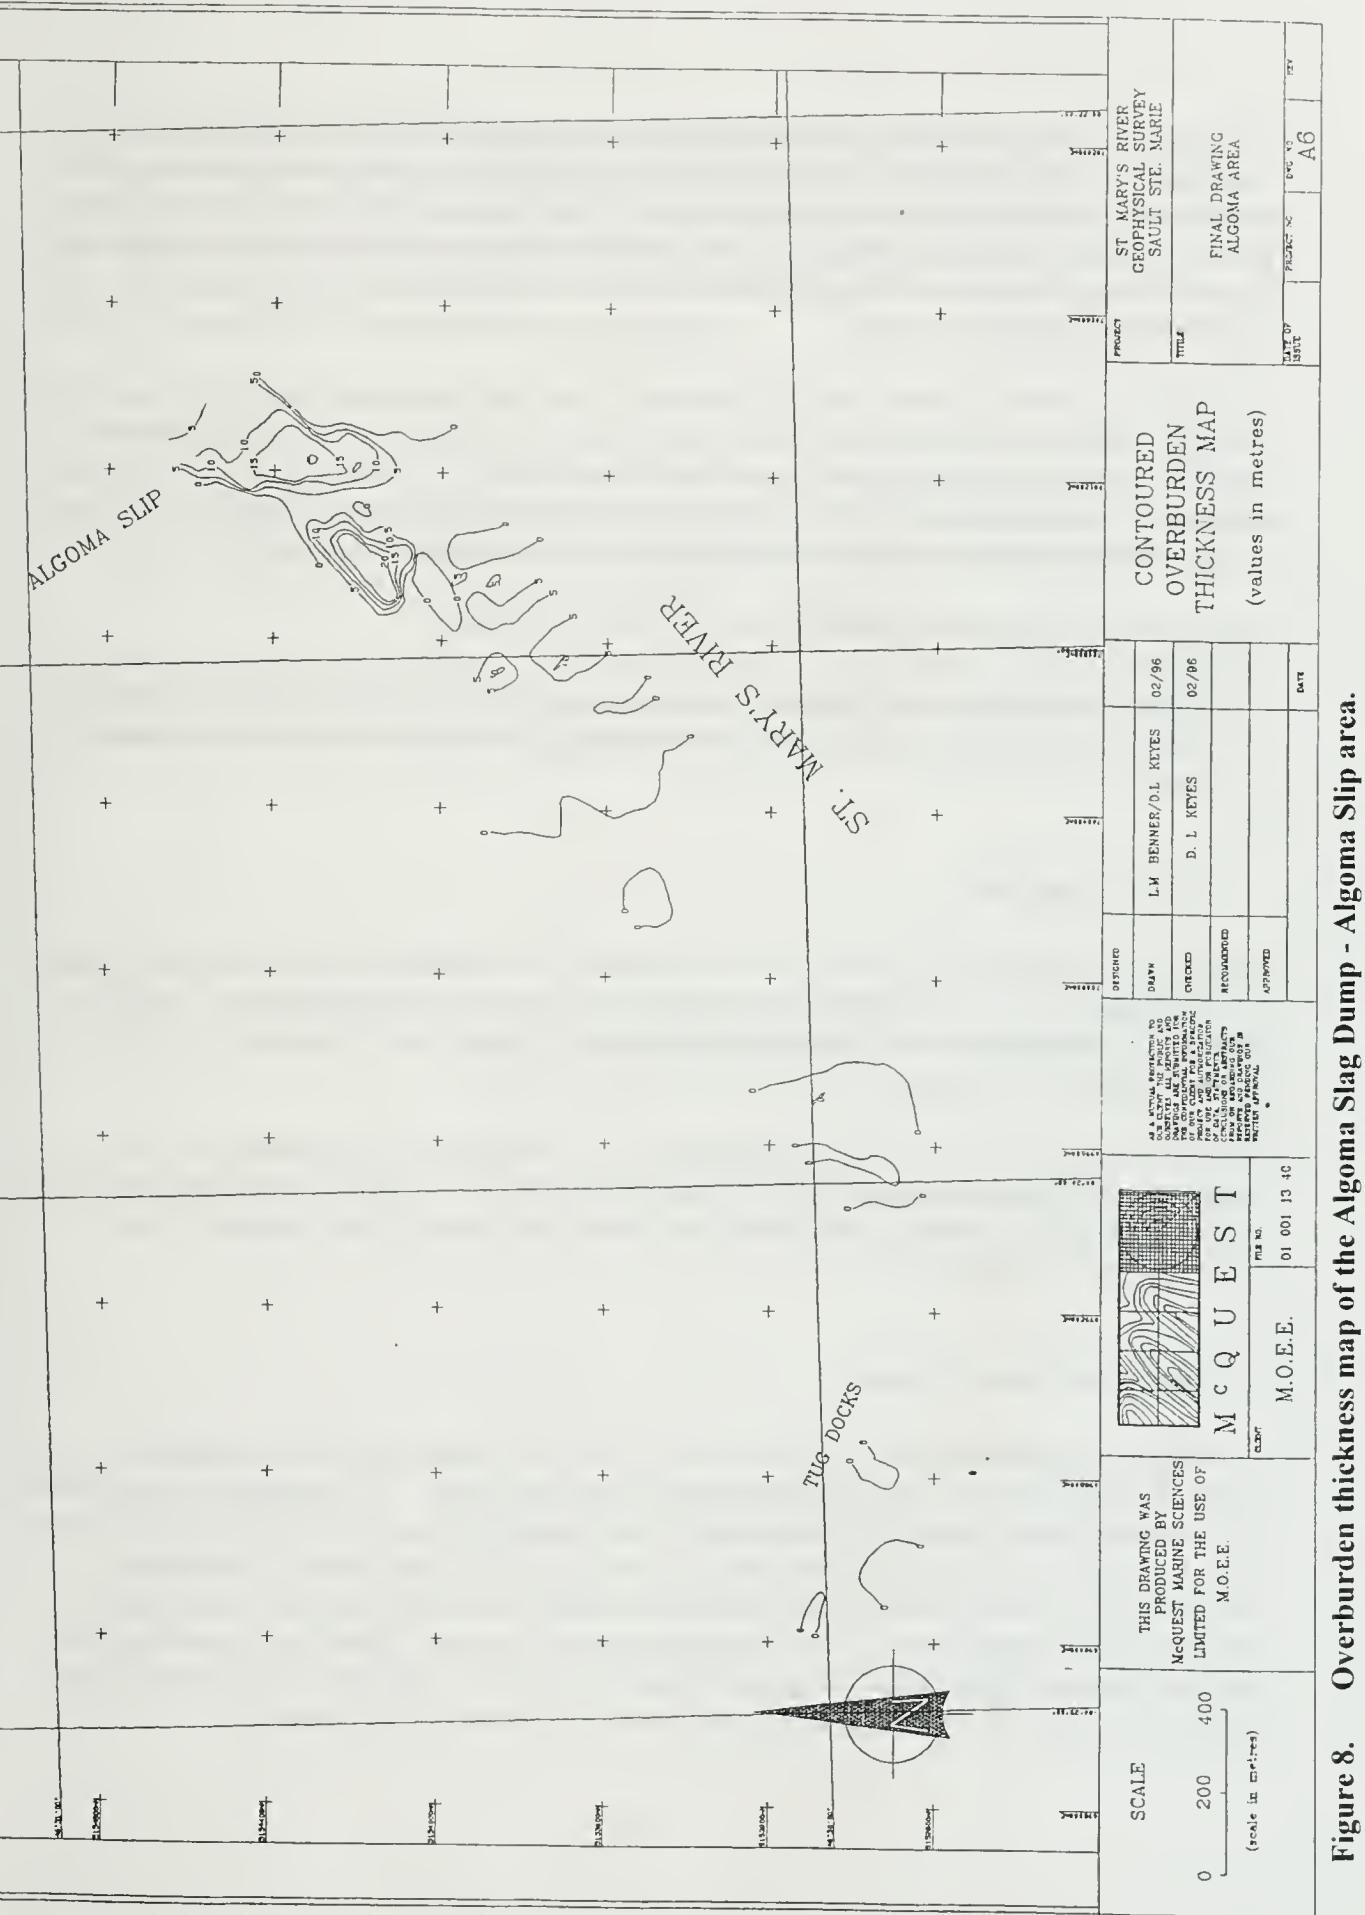
| Numbe | r <u>Title</u> <u>Page</u> | <u>e</u> |
|---|--|---|
| 8 | Overburden thickness map of the Algoma Slag Dump - Algoma Slip area | 11 |

Little or no bottom penetration was achieved in areas with gaseous sediments and/or shallow water and/or heavy weed cover. It was not possible to determine overburden thicknesses in the Algoma Slip due to side reflections from the dock walls. In areas where sufficient overburden thickness values could be determined, it was possible to provide contouring of these values (see Fig. 8). Where penetration to the bedrock/till horizon was possible, the bottom sediments consisted predominantly of clays.

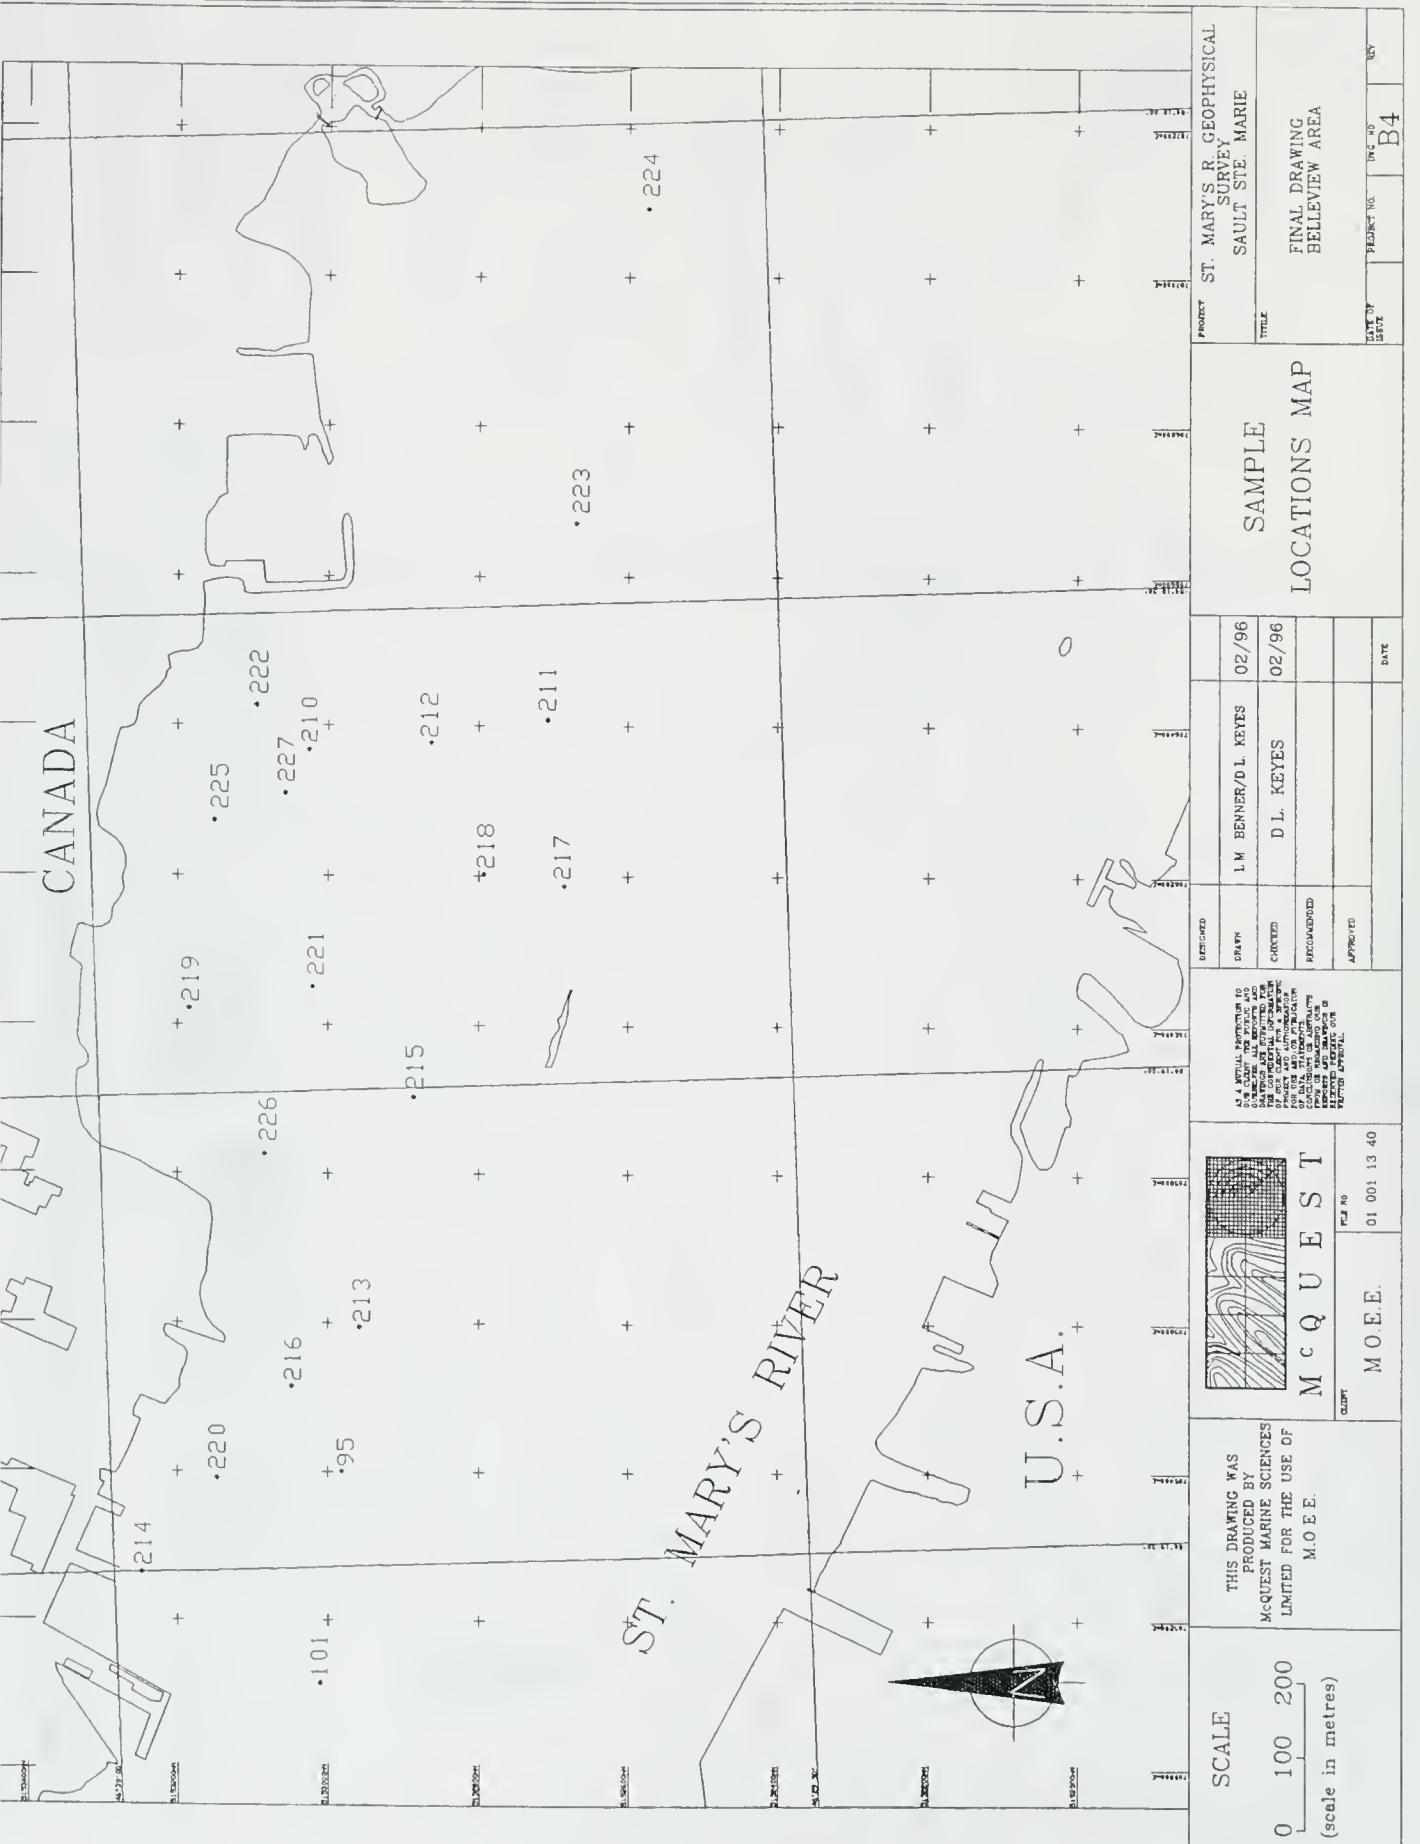
Figure A-2. Sediment sampling locations in the Bellevue Marine Park area.
